**Purpose:** RCRA Compliance Evaluation Inspection

**Facility:** Trendwood, Inc.

**Location  
Address:** 261 East University Drive

**Date of Inspection:** 12/2/2014

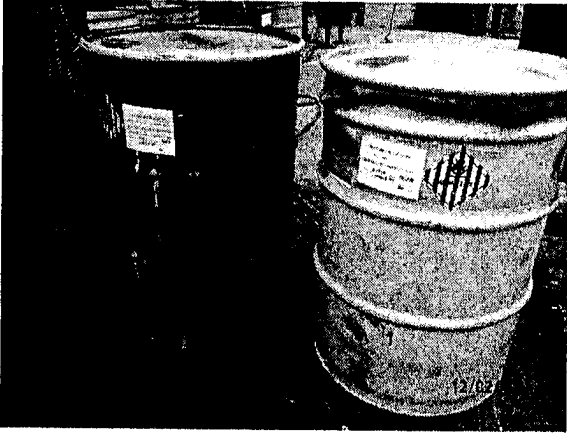
<p>Photo #1</p>

Hazardous waste was observed outside the shop in two sealed ring-type 55-gallon drums containing spent filters and dust that were both labelled (Photo #1). EPA disagrees with Trendwood's interpretation that this is a Satellite Accumulation Area (SAA) because it is not at or near the point of generation under the control of the generator. It should be considered a 90-day HWAA. Also in this area was a 55-gallon bung-type drum with a funnel to collect spent solvents (Photo #2). This drum was unlabeled and the funnel was open when it was first observed. At the sealer spray booth, an unsealed, unlabeled drum was collecting dust swept off the filters onto the floor (Photo #3). This dust is hazardous waste and this drum should be a SAA container. Note – ADEQ stated in their 2004 inspection report that the hazardous waste SAA must be at or near the point of generation but made no mention of this in the 2012 inspection report.

Observation	Photograph
<p>1. Drums on spill pallet. EPA does not consider this a SAA because it is not at or near the point of generation under the control of the operator.</p>

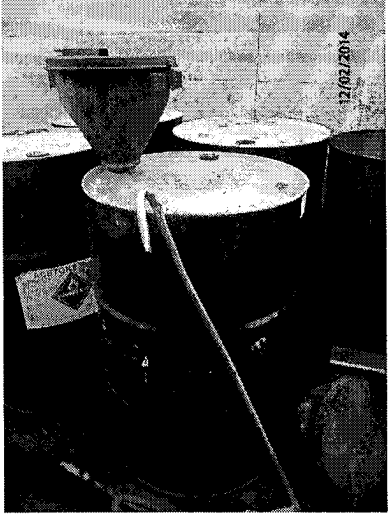
Observation	Photograph
<p>2. Drum collecting solvents. Lid on funnel was open when first observed.</p>

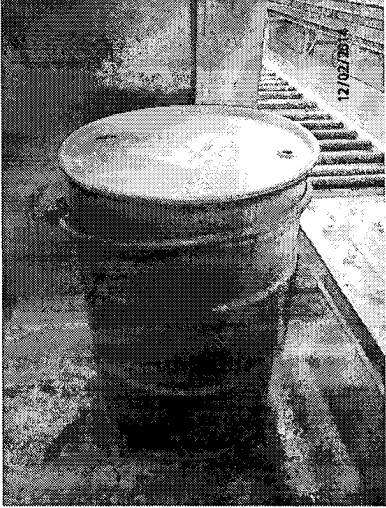
<p>Photo #2</p>
<p>3. Unlabeled and unsealed drum at spray booth containing powder removed from paint filters</p>

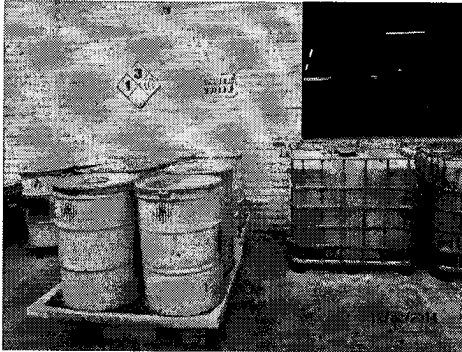
<p>Photo #4</p>

Ten 55-gallon metal drums of RCRA hazardous waste were observed in the HWAA. There was no eyewash/shower, fire extinguisher or alarm/communication device in the area.

Observation	Photograph
1. Drums in 90 day HWAA. All drums were sealed and labeled. There is no eyewash/shower, fire extinguisher or alarm/communication device.
